Inspection Report

345 George St
Winchester ky 40391

Davis Home Inspections LLC

Date: 4/3/2014	Time:	Report ID: 4489
Property: 345 George St Winchester ky 40391	Customer: Mr. James Sample	Real Estate Professional:

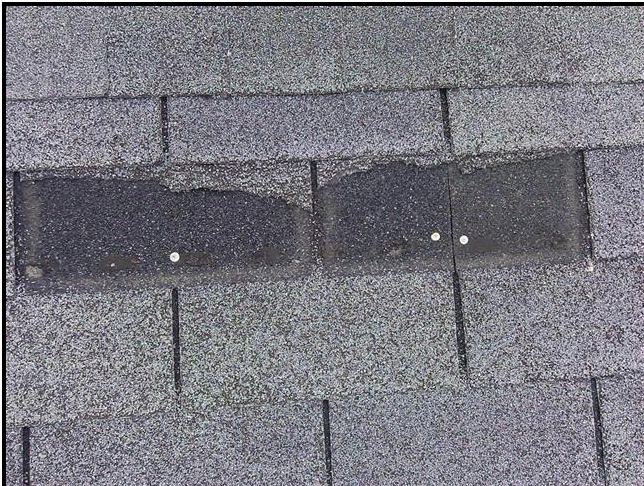
1.0 Item 1(Picture)

The roof shingles are damaged at the rear of home. It should be replaced as soon as possible. This area is a possible roof leak. A qualified person should repair or replace as needed.

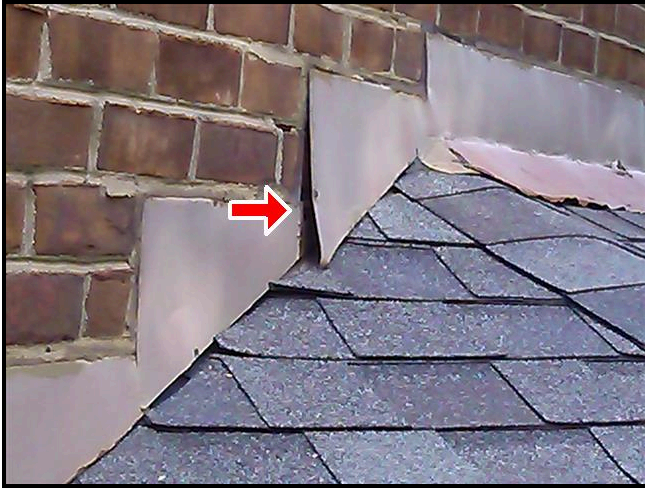
1.1 Item 1(Picture)

The chimney flashing is loose and needs repair.

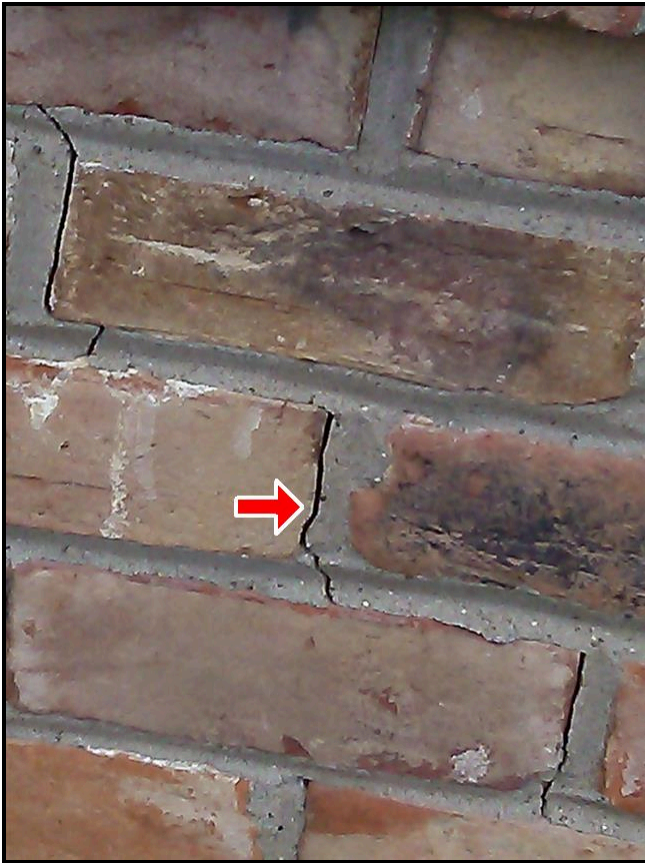
2.0 Item 1(Picture)

(1) The brick siding at the rear of home has hairline cracks. Deterioration can eventually occur if not corrected. I recommend sealing up the cracks. A qualified person should repair.

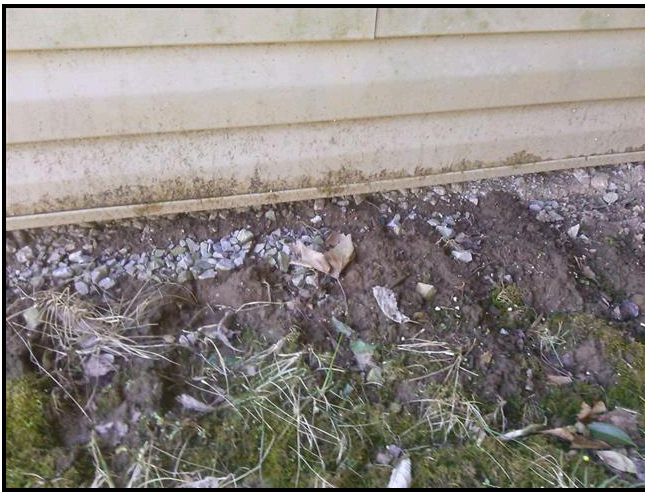
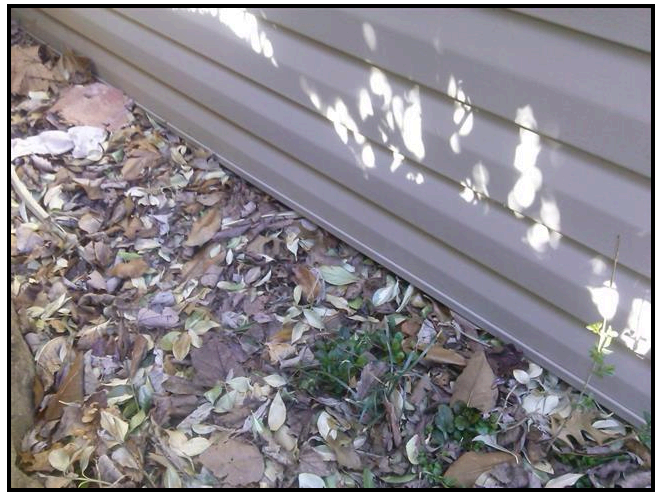
2.0 Item 2(Picture)

(2) Siding in contact with ground at rear addition. Because the siding is in contact with ground it is possible for framing to be deteriorated. We did not inspect behind the siding. Recommend a ground clearance of six to eight inches where possible.

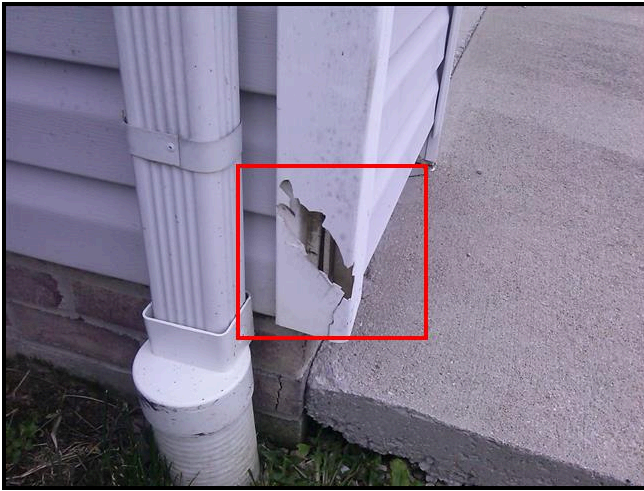
2.0 Item 4(Picture)

(3) The vinyl siding at the rear of home is damaged. Deterioration can eventually occur if not corrected. A qualified person should repair or replace as needed.

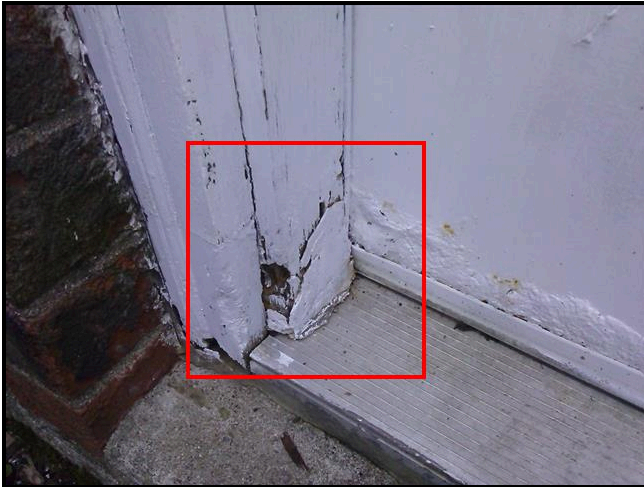
2.1 Item 1(Picture)

- (1) The access door to the crawlspace is deteriorated,. I recommend repair as needed.
- (2) The side entry door has deteriorated at brick-mold or trim (exterior). A repair or replacement is needed. A qualified contractor should inspect and repair as needed.

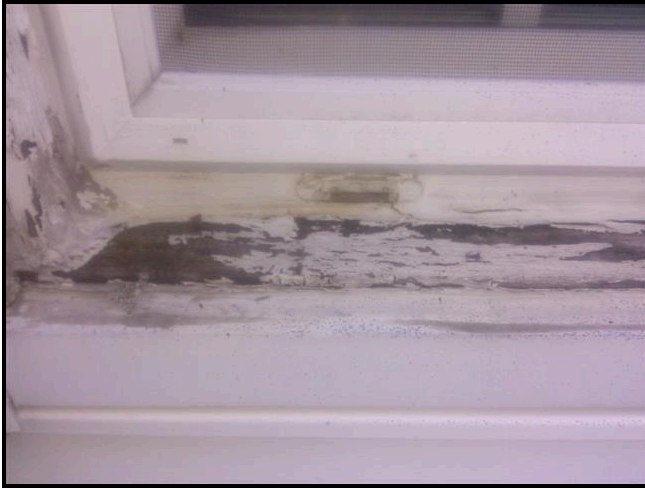
2.2 Item 1(Picture)

The wood trim is peeling paint at most windows. This window has some wood rot, further deterioration may occur if not repaired. I recommend a qualified contractor inspect and repair as needed.

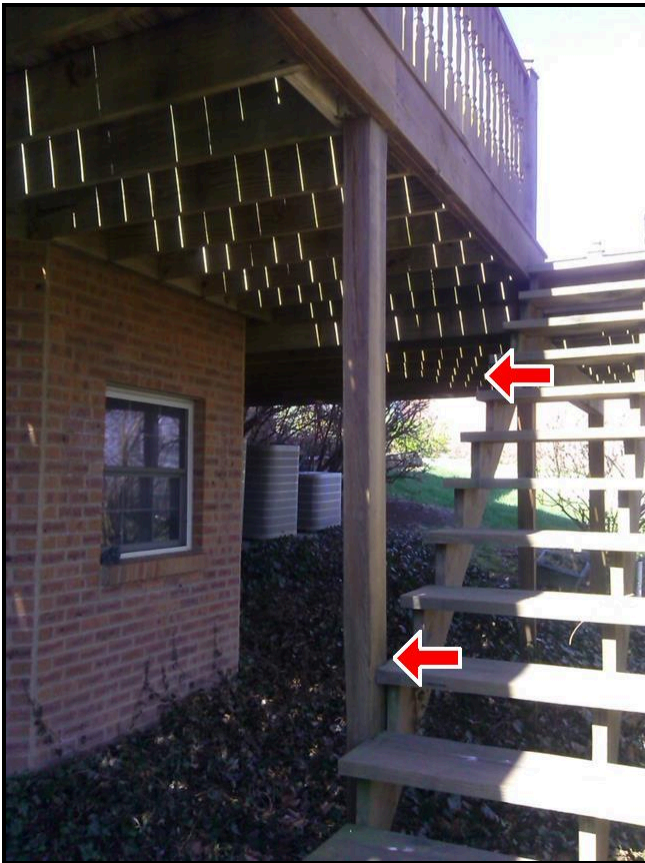
2.3 Item 1(Picture)

The guard rail at steps on the deck at the rear of home is missing. A fall or injury could occur if not corrected. A qualified contractor should repair or replace as needed.

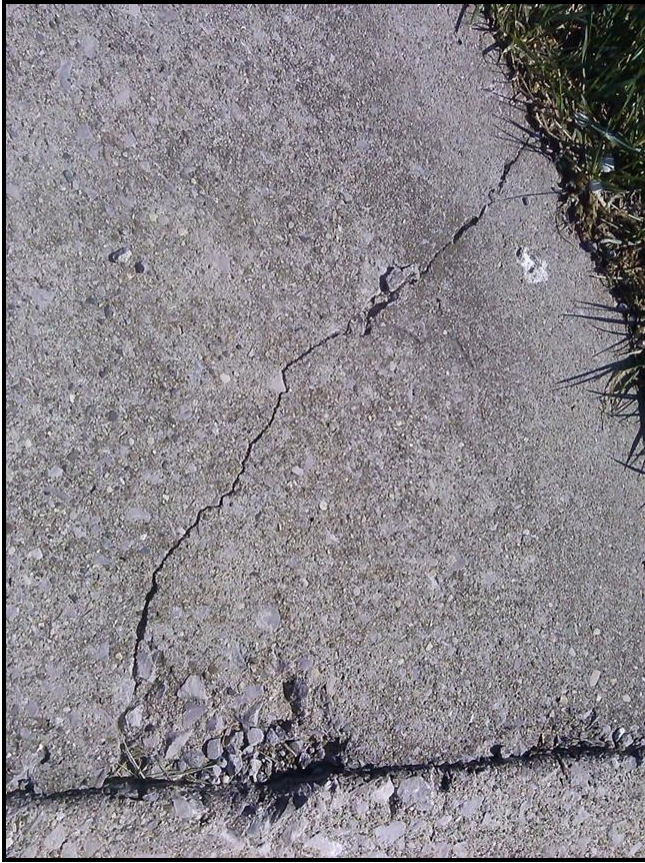
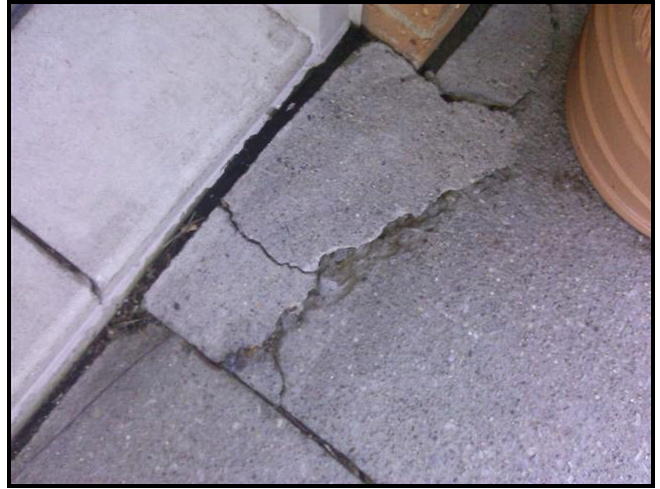
2.4 Item 1(Picture)

- (1) The ground drain located at the rear of home will need periodical cleaning and maintenance.
- (2) The concrete drive at the front of home has settlement cracks. This is typical. I recommend repair if needed.. .

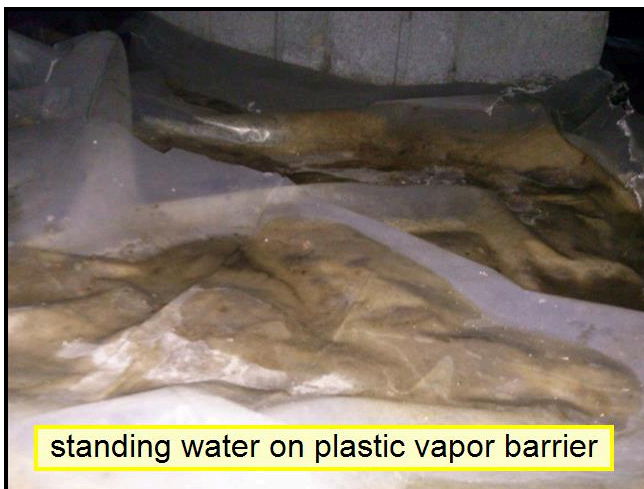
5.0 Item 1(Picture)

(1) Visible signs of water intrusion in the crawlspace are present from standing water. Water intrusion if not corrected can lead to other problems including mold and cause excessive moisture to floor system that can lead to deterioration and increased repair cost.. I recommend further investigation or correction by a qualified licensed contractor or water infiltration specialist.

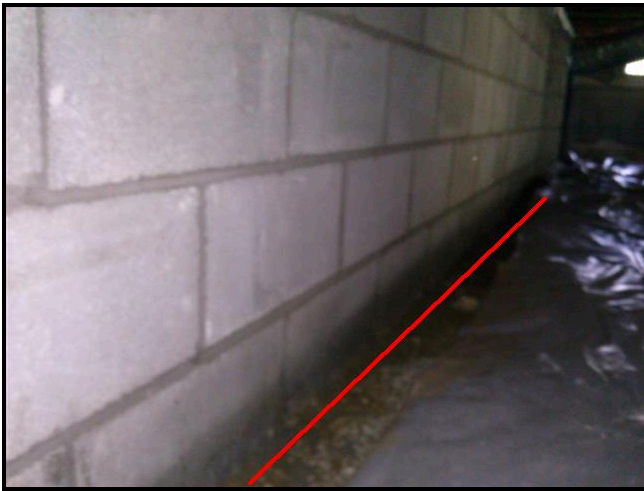
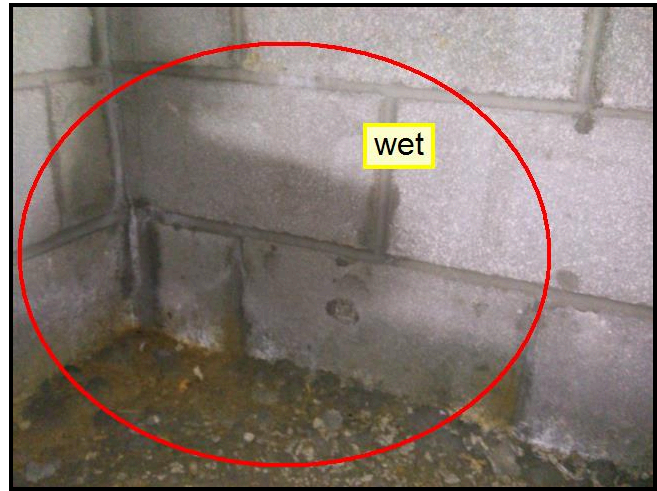
5.0 Item 2(Picture)

(2) Visible signs of water intrusion in the crawlspace are present from water along the block wall. Water intrusion if not corrected can lead to other problems including mold and cause excessive

moisture to floor system that can lead to deterioration and increased repair cost.. I recommend further investigation or correction by a qualified licensed contractor or water infiltration specialist.

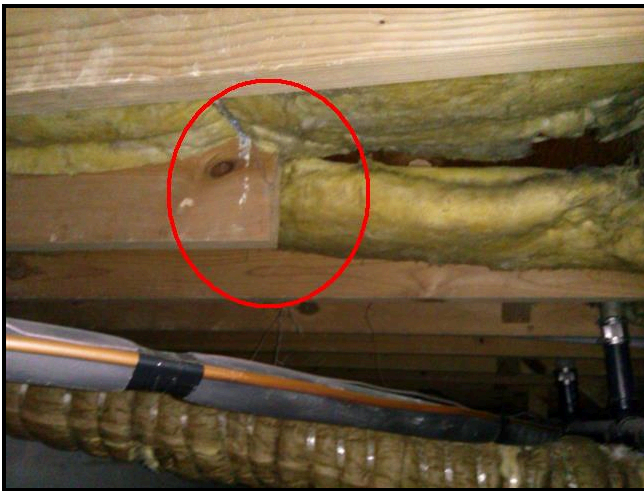
5.3 Item 1(Picture)

(1) Floor joist(s) cut or damaged by tradesman under the washer/dryer room. A proper support is needed where joist(s) are cut. A qualified licensed general contractor should inspect further and repair as needed.

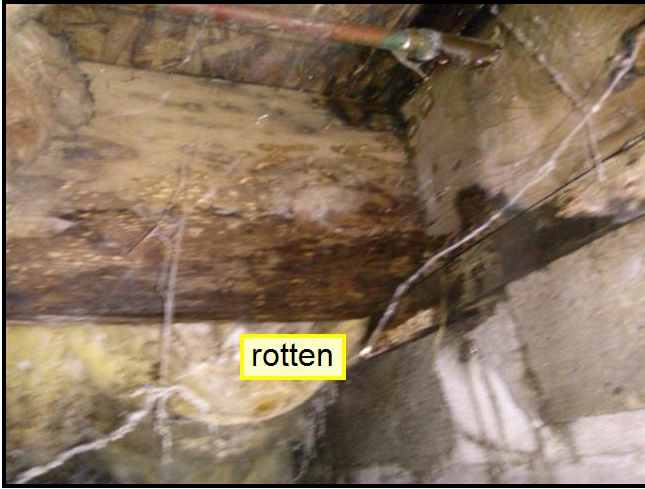
5.3 Item 2(Picture)

(2) Several floor joist(s) are deteriorated from moisture absorption or water intrusion under the home. Repairs are needed. I recommend a qualified engineer inspect and repair or replace as needed.

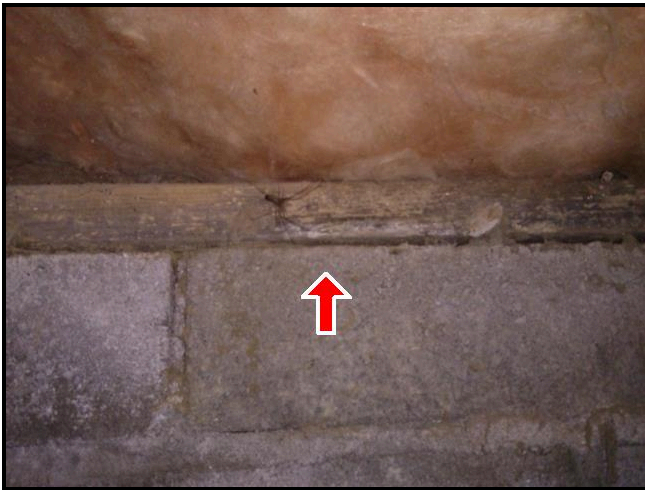
5.3 Item 3(Picture)

(3) Seal plate is deteriorated from wood eating insects under the dining room in the crawl space. I recommend a licensed pest control company inspect and advise.

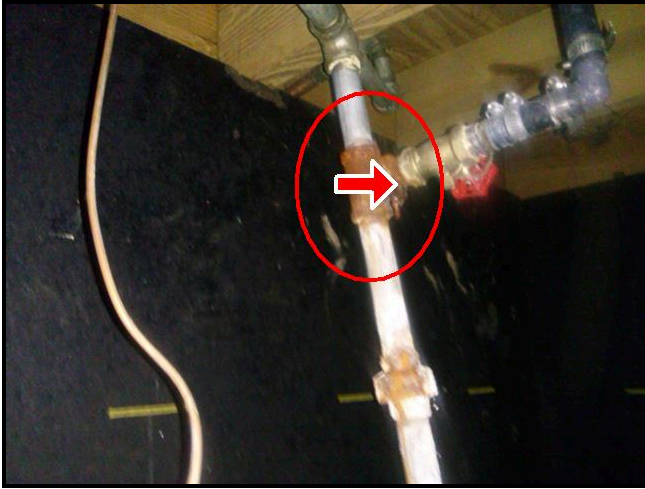
6.1 Item 1(Picture)

(2) The old galvanized supply line is leaking in the crawlspace. Water leaking under home can cause problems such as mold, erosion or deterioration. A qualified licensed plumber should repair or correct as needed.

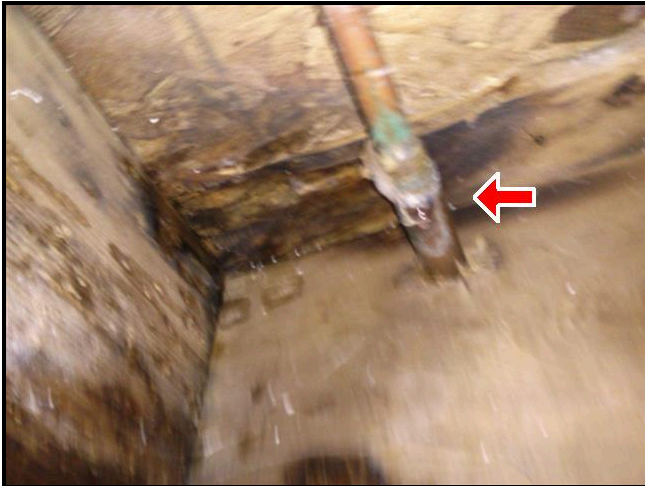
6.1 Item 2(Picture)

(3) The outside water faucet at the rear of home has a broken water line inside the crawl space. Water leaking under home can cause problems such as mold, erosion or deterioration. There is wood rot on the floor joist, band, and seal plate. A qualified licensed plumber should repair or correct as needed.

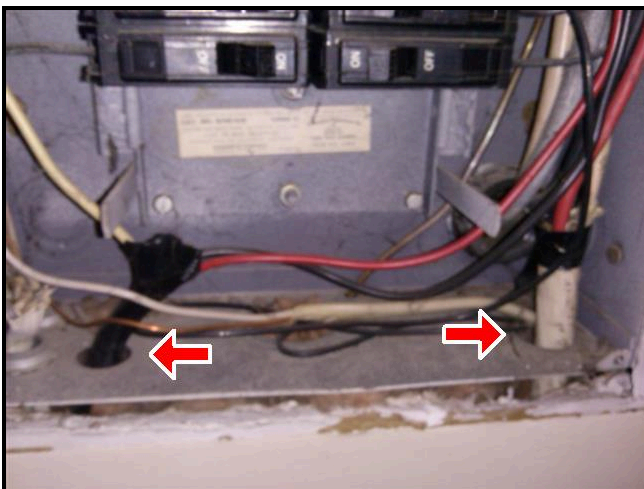
7.1 Item 1(Picture)

The problem(s) discovered in the panel such as romex connectors missing, and any other problems that an electrical contractor may discover while performing repairs need correcting. I recommend a licensed electrical contractor inspect further and correct as needed.

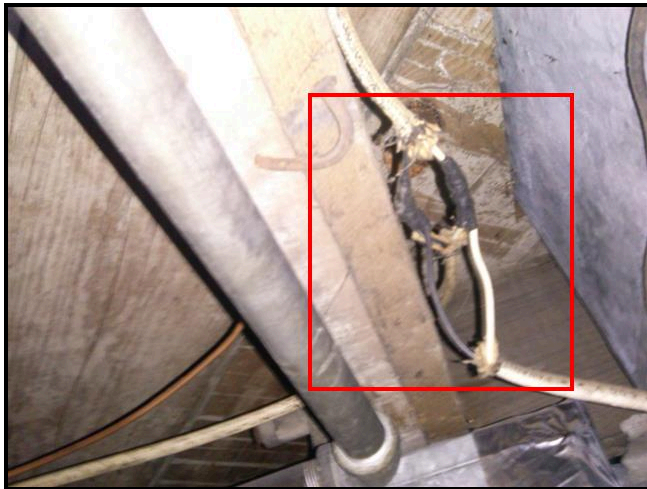
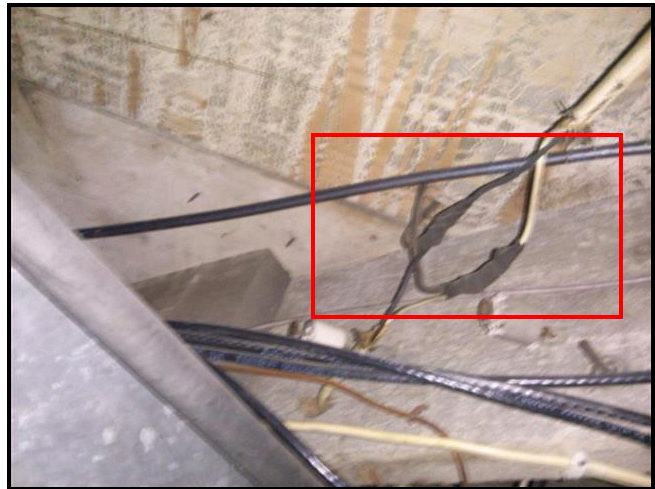
7.3 Item 1(Picture)

(2) Two or more open splices need placing in boxes with cover-plates in the crawlspace. A qualified licensed electrical contractor should perform repairs that involve wiring.

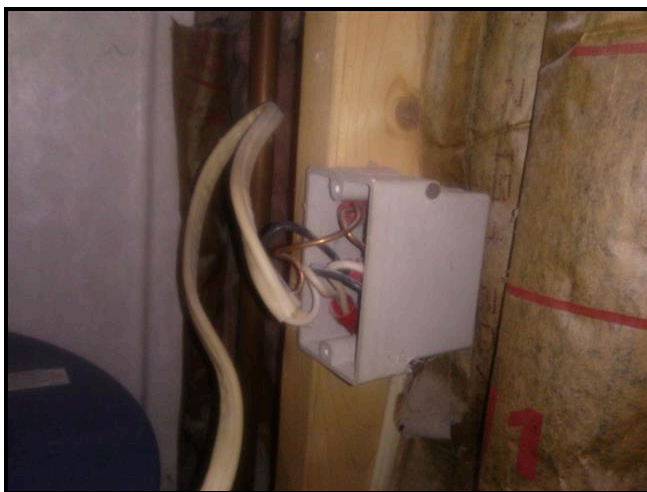
7.3 Item 3(Picture)

(3) The wiring for the water heater has an open splice. Electrical issues are considered a hazard until repaired. I recommend a licensed electrical contractor correct as necessary.

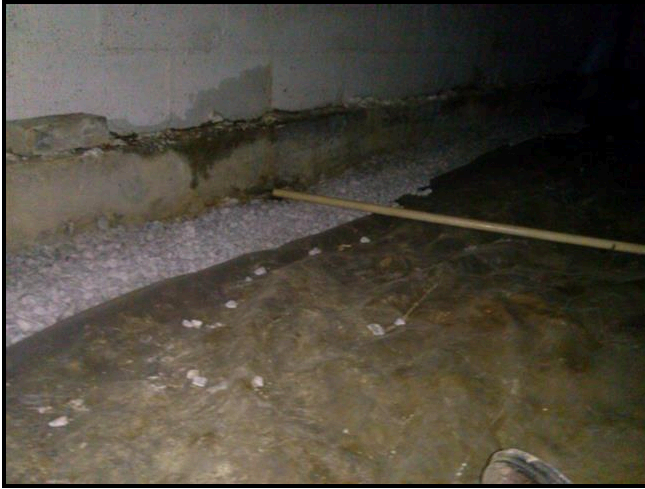
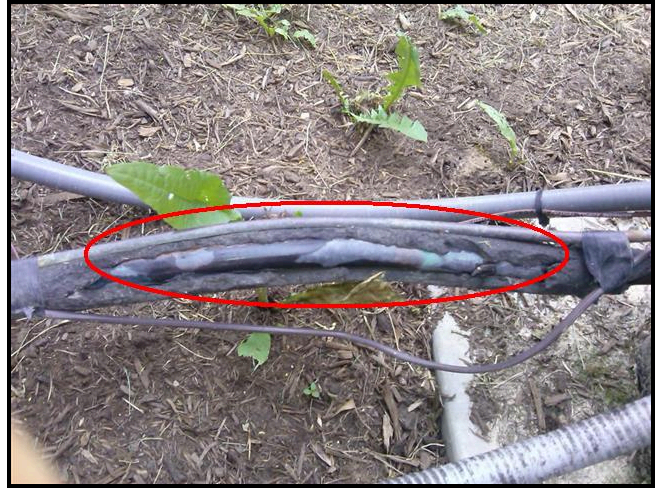
8.0 Item 1(Picture)

The foam sleeve on suction line at outside unit. Missing foam on suction line can cause energy loss and condensation. I recommend repair.

Condensate line draining into the crawl space. Water in the crawl space can cause mold and wood deterioration. I recommend the condensate line be run to the outside of the home by a licensed contractor.

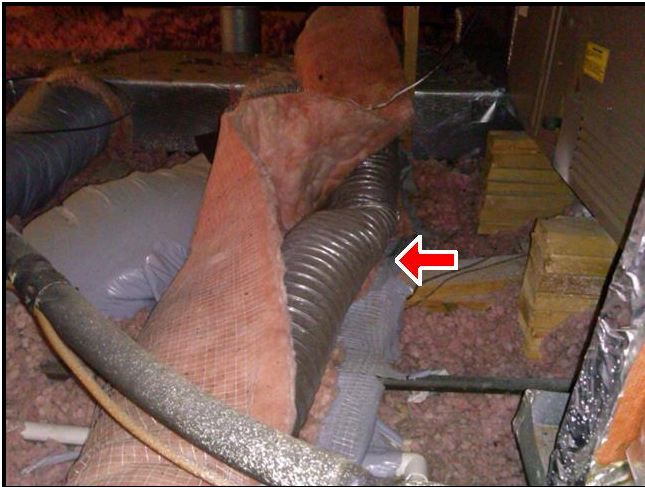
8.2 Item 1(Picture)

- (1) The condensation line needs an extension to carry water away from home. A qualified person should repair or replace as needed.
- (2) The supply duct pipe is not insulated and condensation may occur in the attic. Energy loss is occurring in attic and immediate correction is needed. A qualified HVAC person should inspect further and repair or replace as needed.

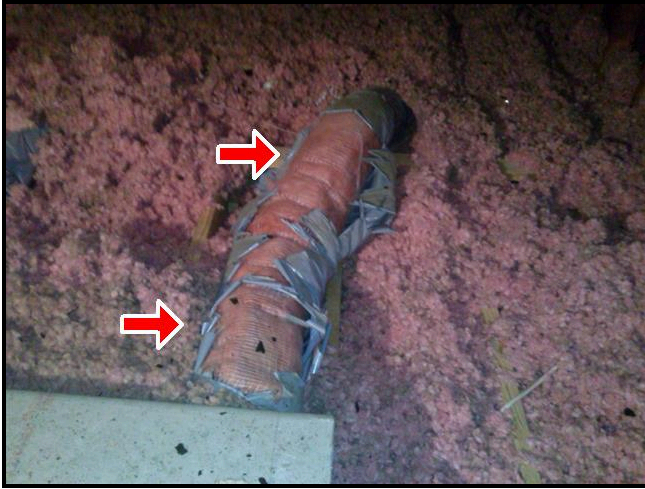
8.2 Item 2(Picture)

- (3) The supply duct pipes plastic covering is deteriorated in the attic. Energy loss is occurring where plastic covering has deteriorated . A qualified HVAC person should inspect further and repair or replace as needed.

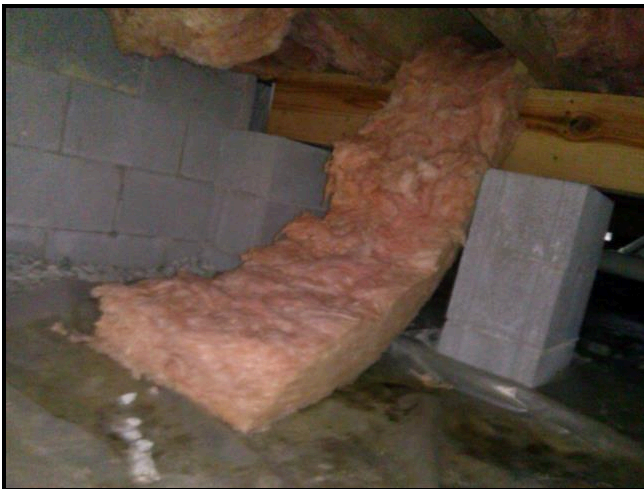
9.1 Item 1(Picture)

The insulation is loose/fallen in the crawlspace. Heat loss can occur more on this home than one that is properly insulated. A qualified person should repair or replace as needed.

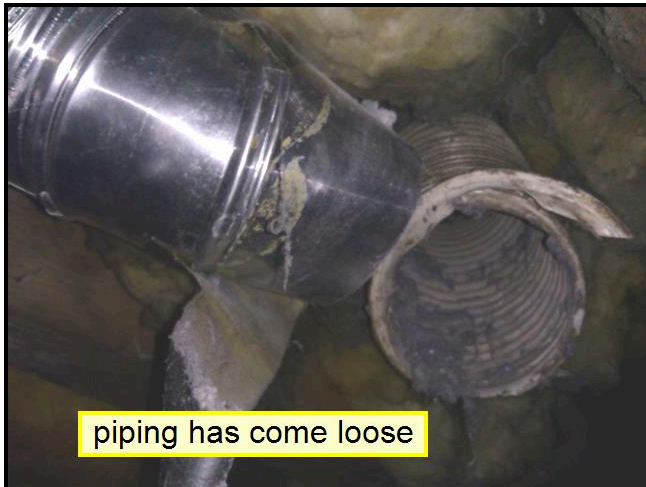
9.4 Item 1(Picture)

(3) The dryer vent piping is loose in crawlspace. Allowing lint to be released in the air is not healthy in closed rooms, crawlspaces or basements. The moisture can cause damage to the wooden structure in the crawlspace. I recommend repair..

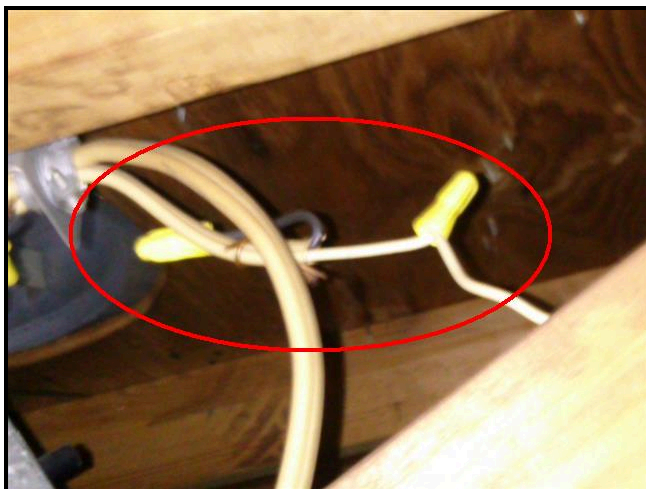
9.5 Item 1(Picture)

Thermostatically controlled vent fan in the attic is using wiring that has an "open-splice" or unsafe. Exposed wiring is considered unsafe until repaired. A qualified licensed electrical contractor should inspect further and repair as needed.

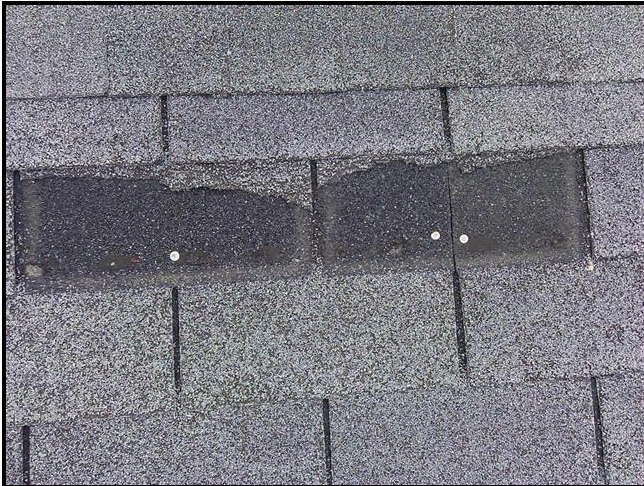
1.0

The roof shingles are damaged at the rear of home. It should be replaced as soon as possible.This area is a possible roof leak. A qualified person should repair or replace as needed.

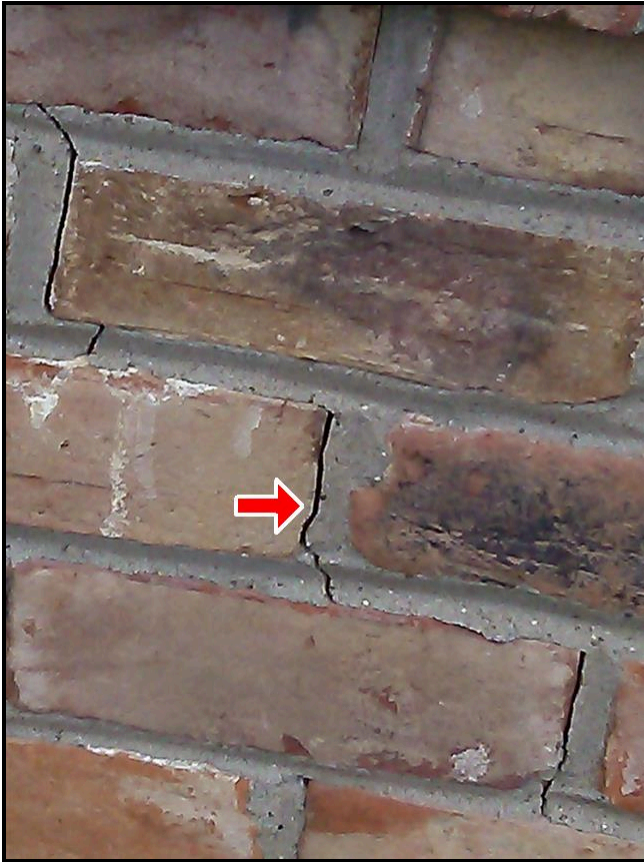
2.0

(1) The brick siding at the rear of home has hairline cracks. Deterioration can eventually occur if not corrected. I recommend sealing up the cracks. A qualified person should repair.

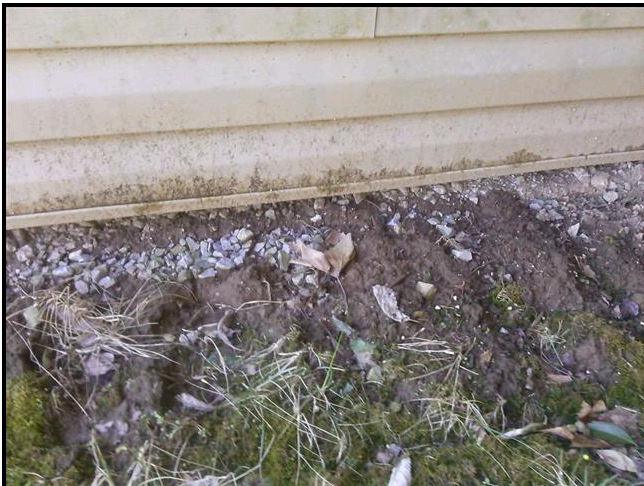
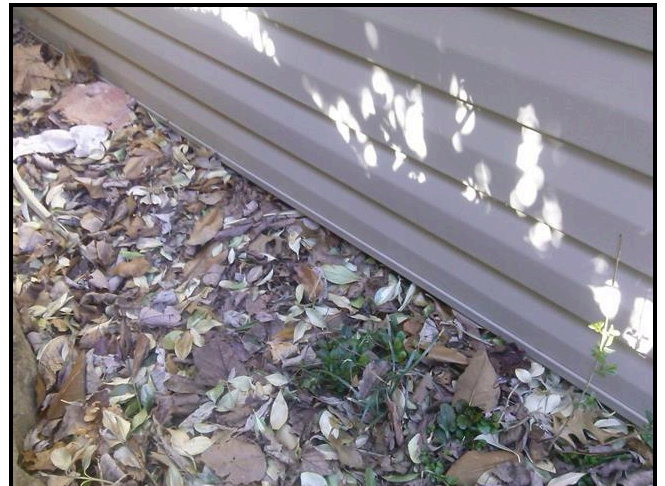
2.0

(2) Siding in contact with ground at rear addition. Because the siding is in contact with ground it is possible for framing to be deteriorated. We did not inspect behind the siding. Recommend a ground clearance of six to eight inches where possible.

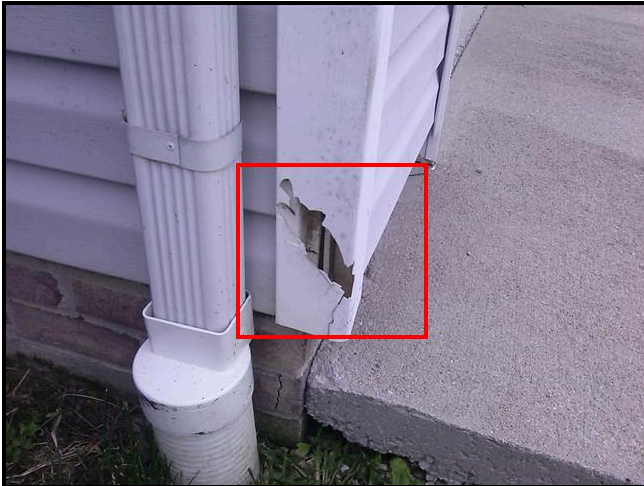
2.0

(3) The vinyl siding at the rear of home is damaged. Deterioration can eventually occur if not corrected. A qualified person should repair or replace as needed.

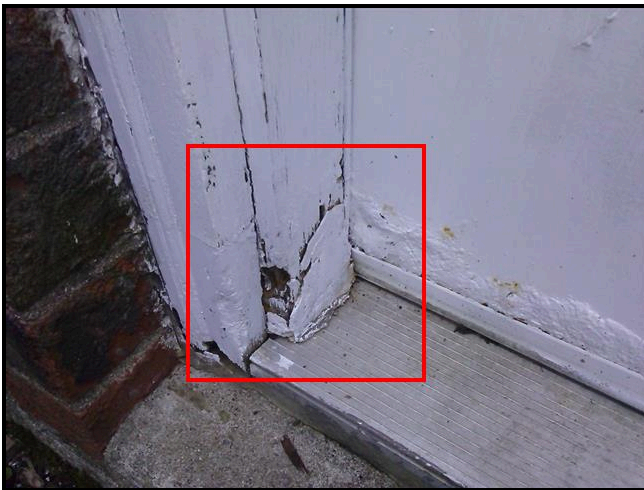
2.1

(1) The access door to the crawlspace is deteriorated,. I recommend repair as needed.

(2) The side entry door has deteriorated at brick-mold or trim (exterior). A repair or replacement is needed. A qualified contractor should inspect and repair as needed.

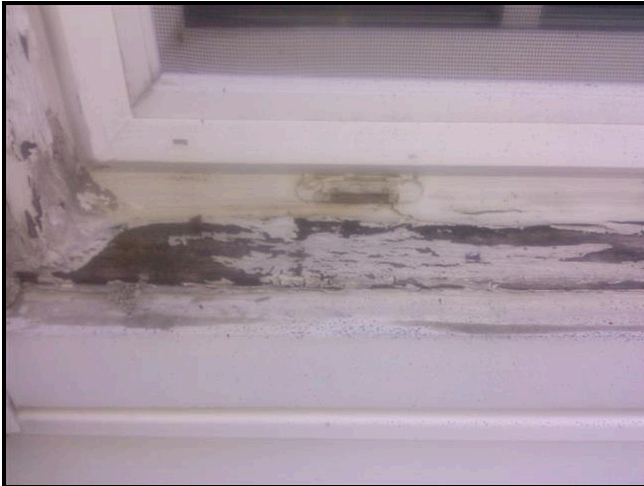
2.2

The wood trim is peeling paint at most windows. This window has some wood rot, further deterioration may occur if not repaired. I recommend a qualified contractor inspect and repair as needed.

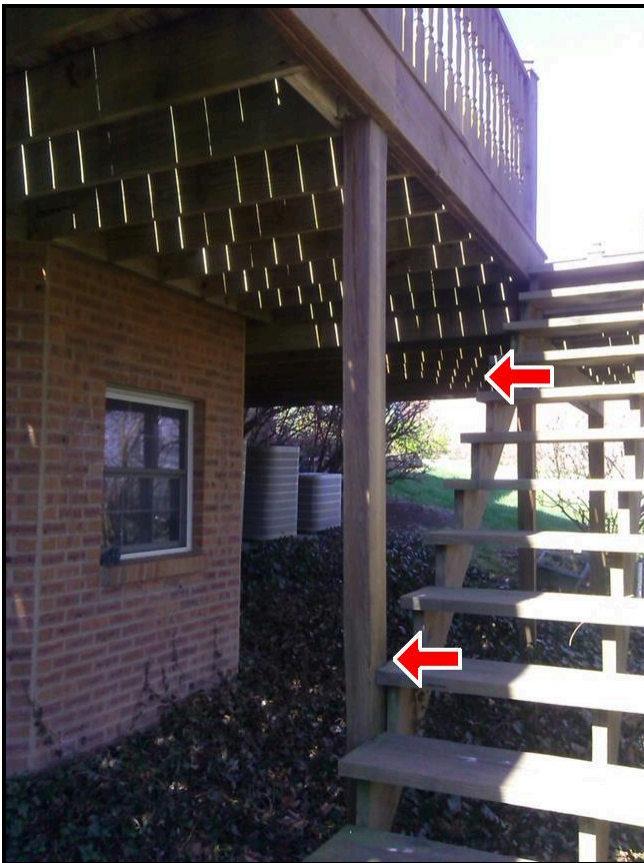
2.3

The guard rail at steps on the deck at the rear of home is missing. A fall or injury could occur if not corrected. A qualified contractor should repair or replace as needed.

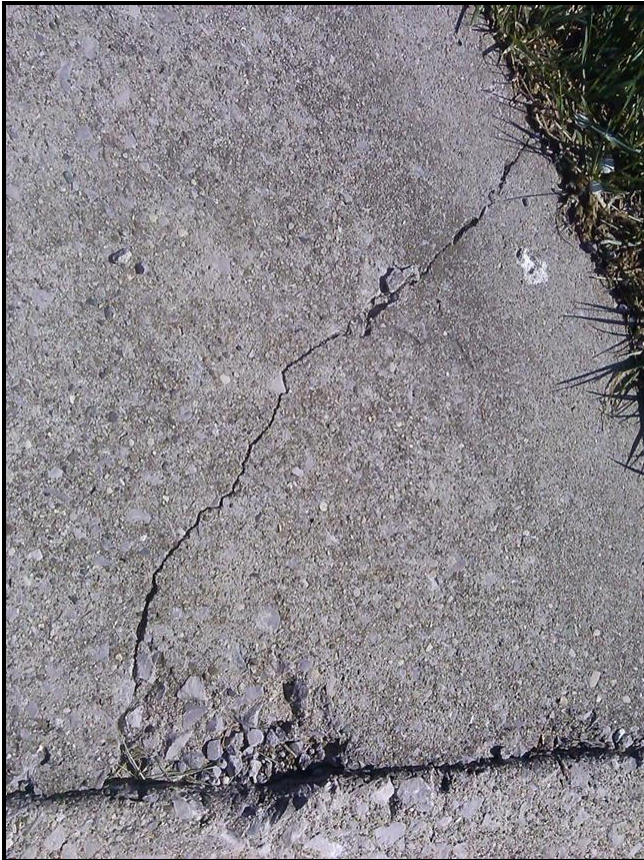
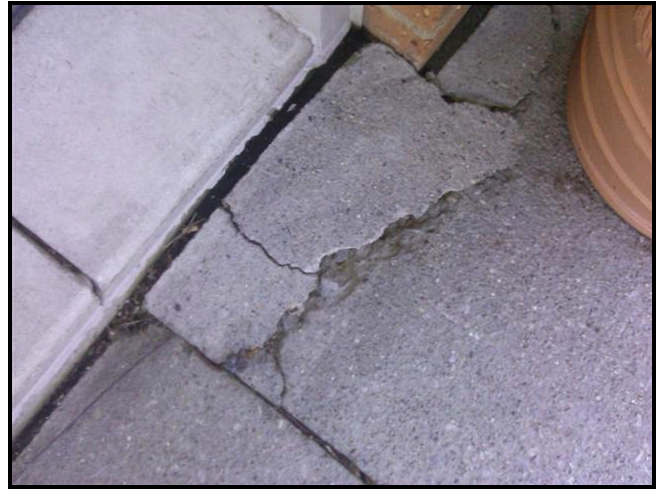
2.4

- (1) The ground drain located at the rear of home will need periodical cleaning and maintenance.
- (2) The concrete drive at the front of home has settlement cracks. This is typical. I recommend repair if needed.. .

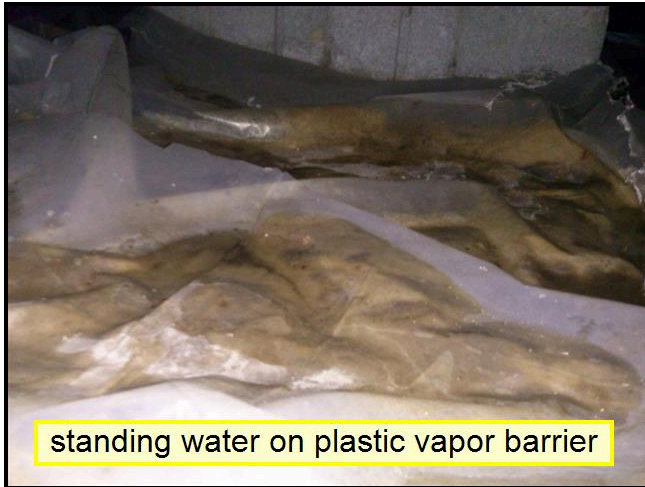
5.0

(1) Visible signs of water intrusion in the crawlspace are present from standing water. Water intrusion if not corrected can lead to other problems including mold and cause excessive moisture to floor system that can lead to deterioration and increased repair cost.. I recommend further investigation or correction by a qualified licensed contractor or water infiltration specialist.

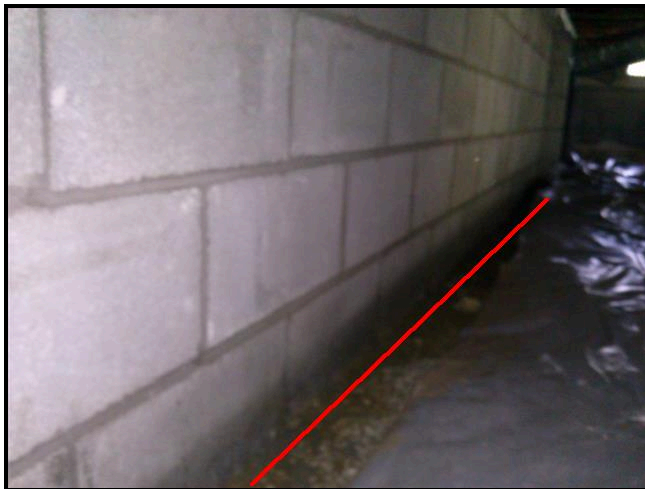
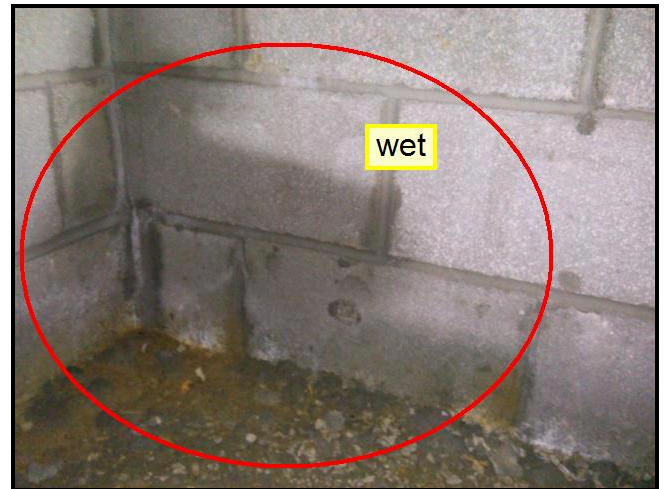
5.0

(2) Visible signs of water intrusion in the crawlspace are present from water along the block wall. Water intrusion if not corrected can lead to other problems including mold and cause excessive moisture to floor system that can lead to deterioration and increased repair cost.. I recommend further investigation or correction by a qualified licensed contractor or water infiltration specialist.

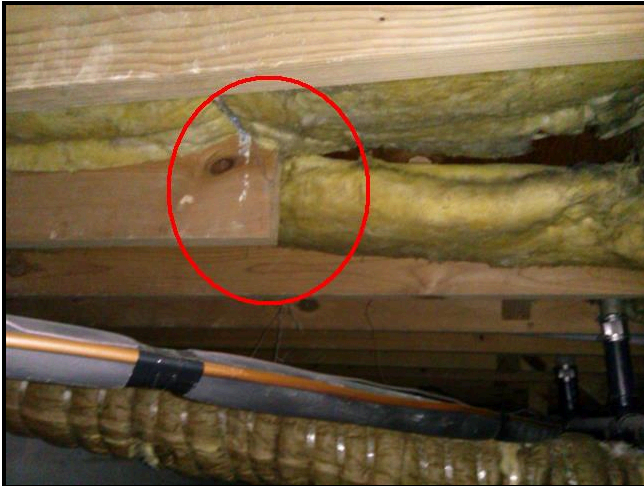
5.3

(1) Floor joist(s) cut or damaged by tradesman under the washer/dryer room. A proper support is needed where joist(s) are cut. A qualified licensed general contractor should inspect further and repair as needed.

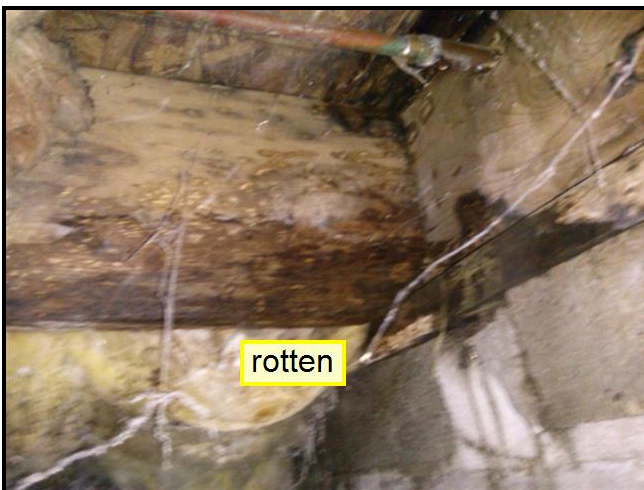
5.3

(2) Several floor joist(s) are deteriorated from moisture absorption or water intrusion under the home. Repairs are needed. I recommend a qualified engineer inspect and repair or replace as needed.

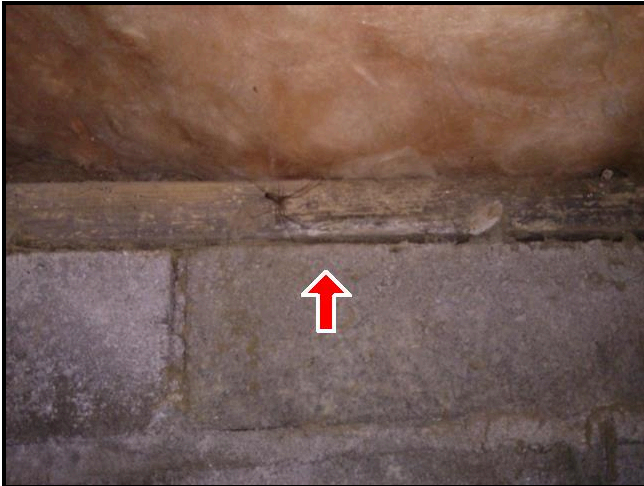
5.3

(3) Seal plate is deteriorated from wood eating insects under the dining room in the crawl space. I recommend a licensed pest control company inspect and advise.

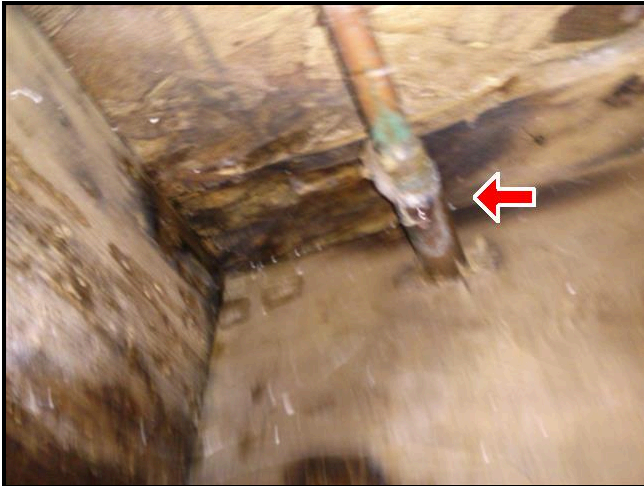
6.1

- (3) The outside water faucet at the rear of home has a broken water line inside the crawl space. Water leaking under home can cause problems such as mold, erosion or deterioration. There is wood rot on the floor joist, band, and seal plate. A qualified licensed plumber should repair or correct as needed.

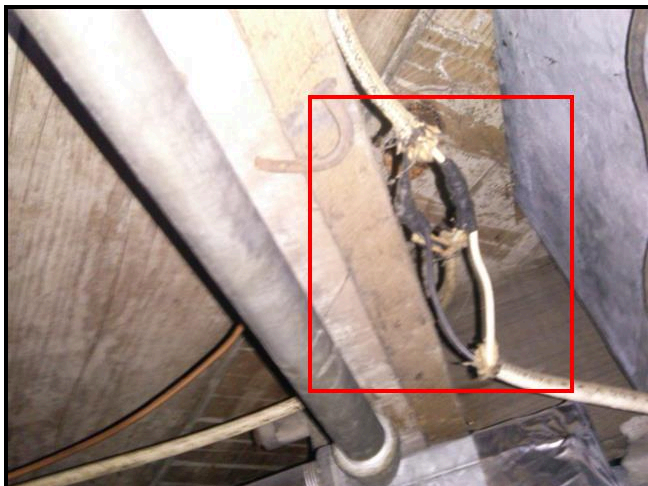
7.3

(2) Two or more open splices need placing in boxes with cover-plates in the crawlspace. A qualified licensed electrical contractor should perform repairs that involve wiring.

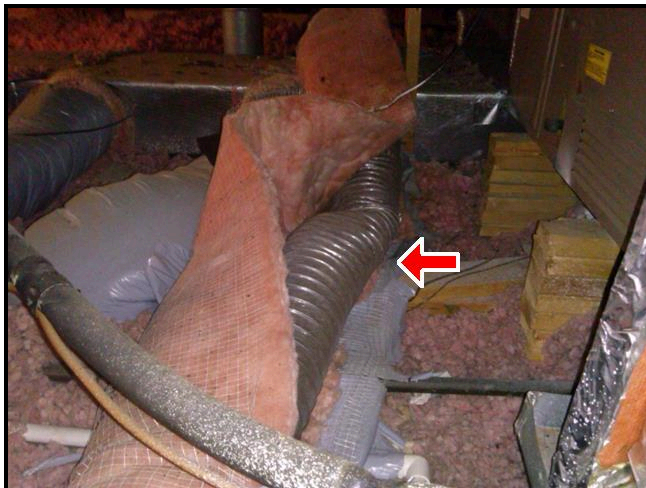
8.2

(1) The condensation line needs an extension to carry water away from home. A qualified person should repair or replace as needed.

(2) The supply duct pipe is not insulated and condensation may occur in the attic. Energy loss is occurring in attic and immediate correction is needed. A qualified HVAC person should inspect further and repair or replace as needed.

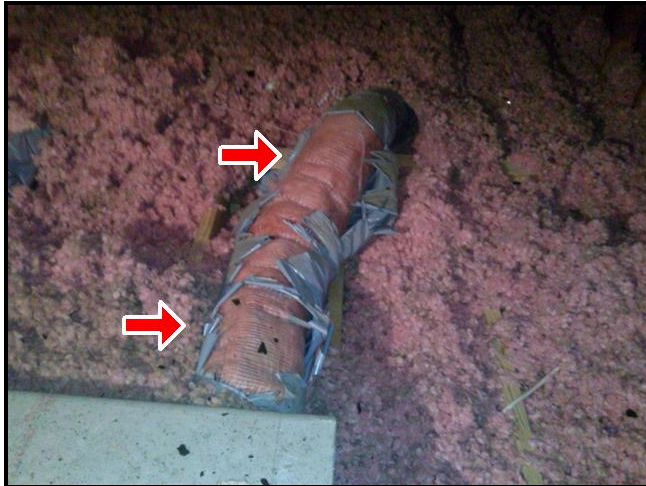
8.2

(3) The supply duct pipes plastic covering is deteriorated in the attic. Energy loss is occurring where plastic covering has deteriorated. A qualified HVAC person should inspect further and repair or replace as needed.

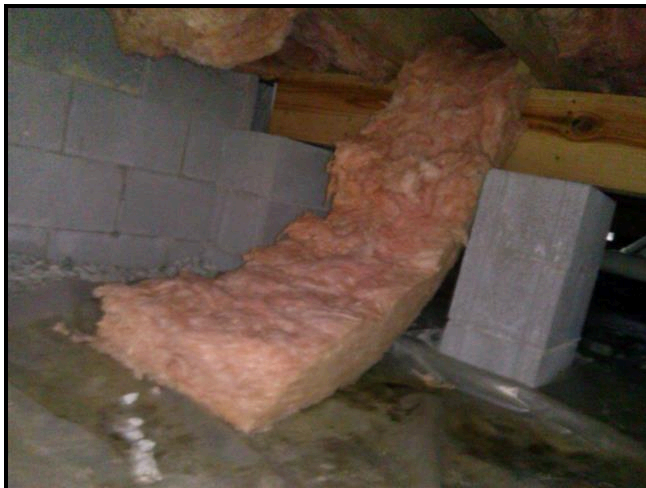
9.1

The insulation is loose/fallen in the crawlspace. Heat loss can occur more on this home than one that is properly insulated. A qualified person should repair or replace as needed.

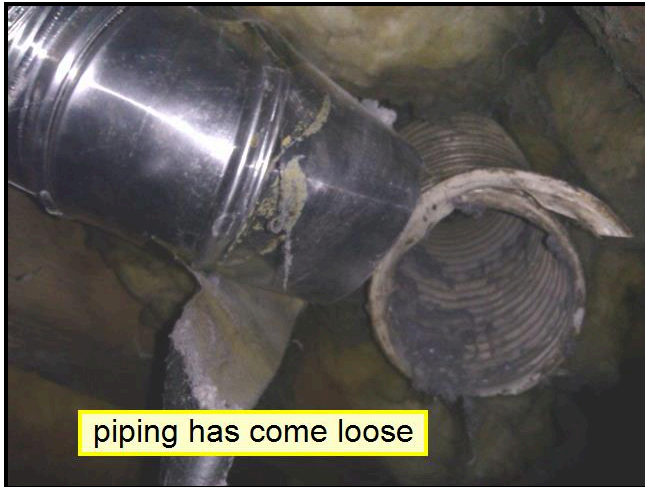
9.4

(3) The dryer vent piping is loose in crawlspace. Allowing lint to be released in the air is not healthy in closed rooms, crawlspaces or basements. The moisture can cause damage to the wooden structure in the crawlspace. I recommend repair..

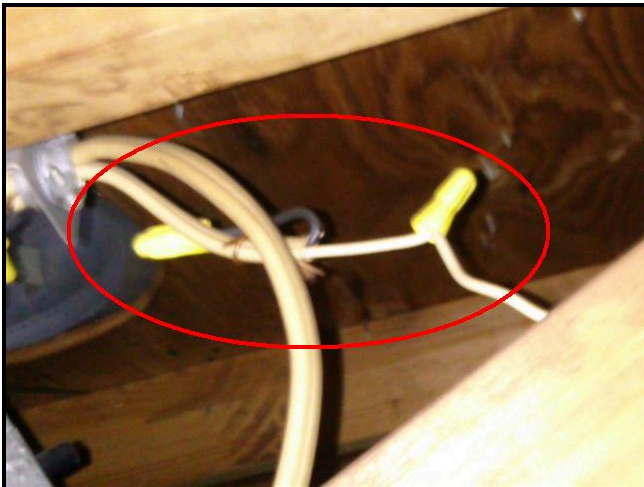
9.5

Thermostatically controlled vent fan in the attic is using wiring that has an "open-splice" or unsafe. Exposed wiring is considered unsafe until repaired. A qualified licensed electrical contractor should inspect further and repair as needed.
